FINAL REPORT

**ASSESSMENT OF STATUS OF
RIVERINE WETLANDS IN THE SANTA ANA
AND SAN JACINTO RIVER WATERSHEDS**

Submitted for Review November 30, 2006

*US EPA Funding No. 05-101-180-0
Santa Ana Regional Water Quality Control Board*

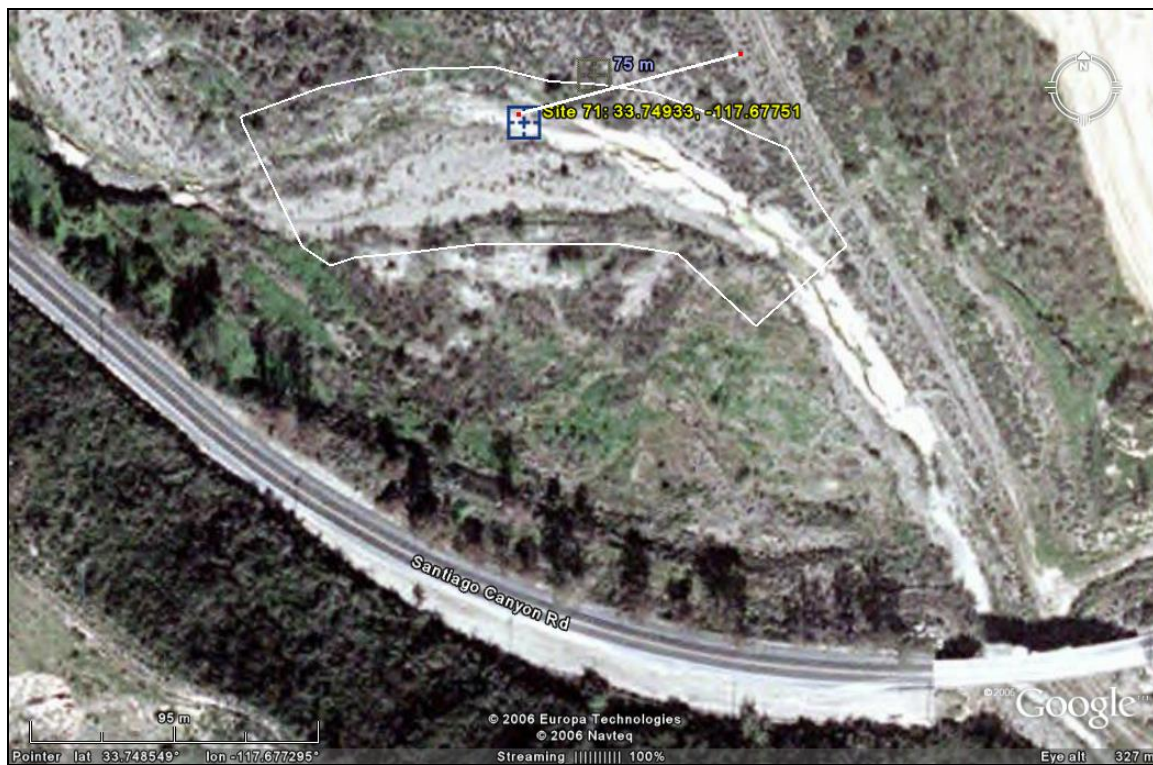
Figure C3: Site 71, close-up view, with ruler and assessment area.
